# ELITE GROUP

1234 Property Address, Any City, CA 92028  
Inspection prepared for: Client Name  
Real Estate Agent: Name Agent - Your Favorite Agency

Date of Inspection: 7/7/2019 Time: 12:00 PM  
Age of Home: 2017 Size: 2486  
Weather: Sunny  
Order ID: 18xxxx

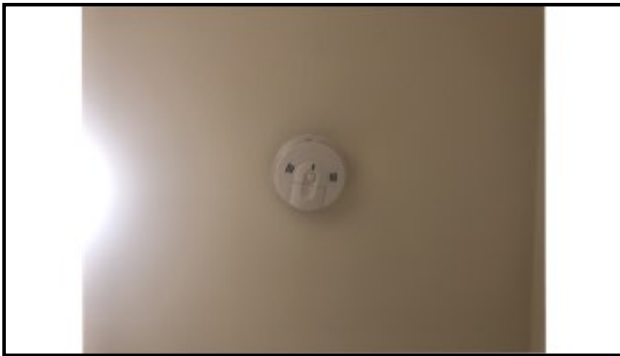
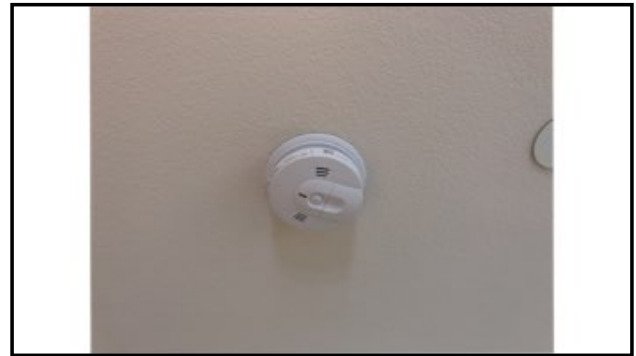
For safety purposes we recommend that smoke detectors be placed in all hallways outside of sleeping areas (bedrooms) and on all levels of multi-level dwellings. For longer hallways and/or oddly located bedrooms, multiple smoke detectors are suggested and should be placed at each end of the hallways to ensure optimum safety alert. • Operational at time of inspection via factory installed test button • Smoke and Carbon Monoxide combo unit is present

**Smoke and Carbon Monoxide combo unit is present**

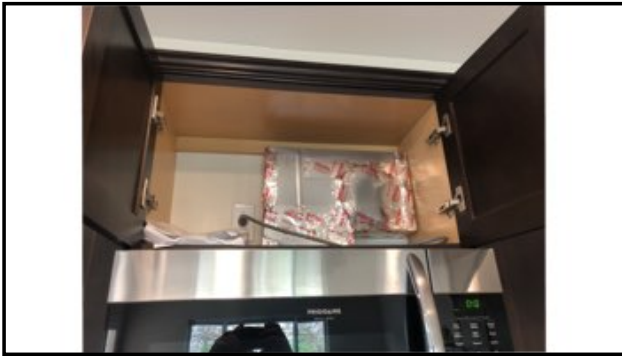
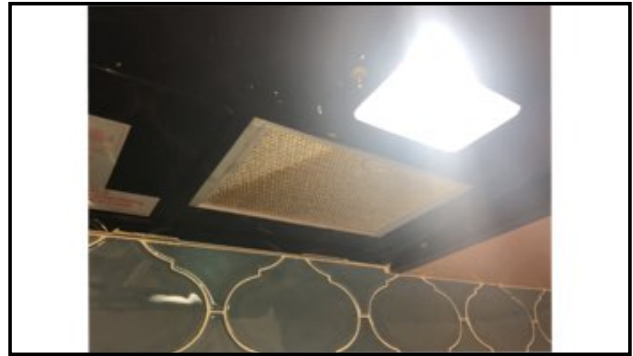
The exhaust fan/vent is tested using the normal controls only. No smoke testing or other testing is done to determine the CFMs or how well the unit evacuates air. The home inspector cannot predict the remaining life left in the unit. • Tested and operational at time of inspection via normal controls • Normal wear for age - no major visible defects • Worn/dirty filters, recommend cleaning or replacing

**Worn/dirty filters, recommend cleaning or replacing**

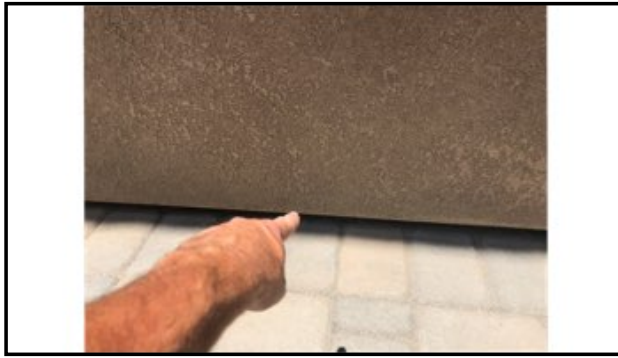
**Weep screeds should be minimum 4-inches from grade - needs to be serviced**
