ELITE GROUP
INSPECTION PROFESSIONALS

PROPERTY LOCATION: 45991 S Main Blvd Ontario, CA 91761

INSPECTIONREPORT

Date of Inspection: 6/24/2025 at 10:00 AM
Year Built: 2021 Sq Ft: 1411
Weather: Cloudy, cool and dry
Order ID: 37xxx

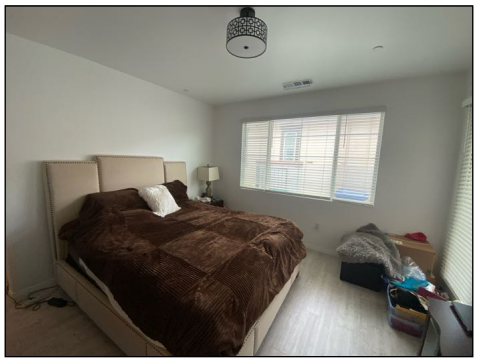
Patched/partial painted areas present - consult seller regarding patched areas

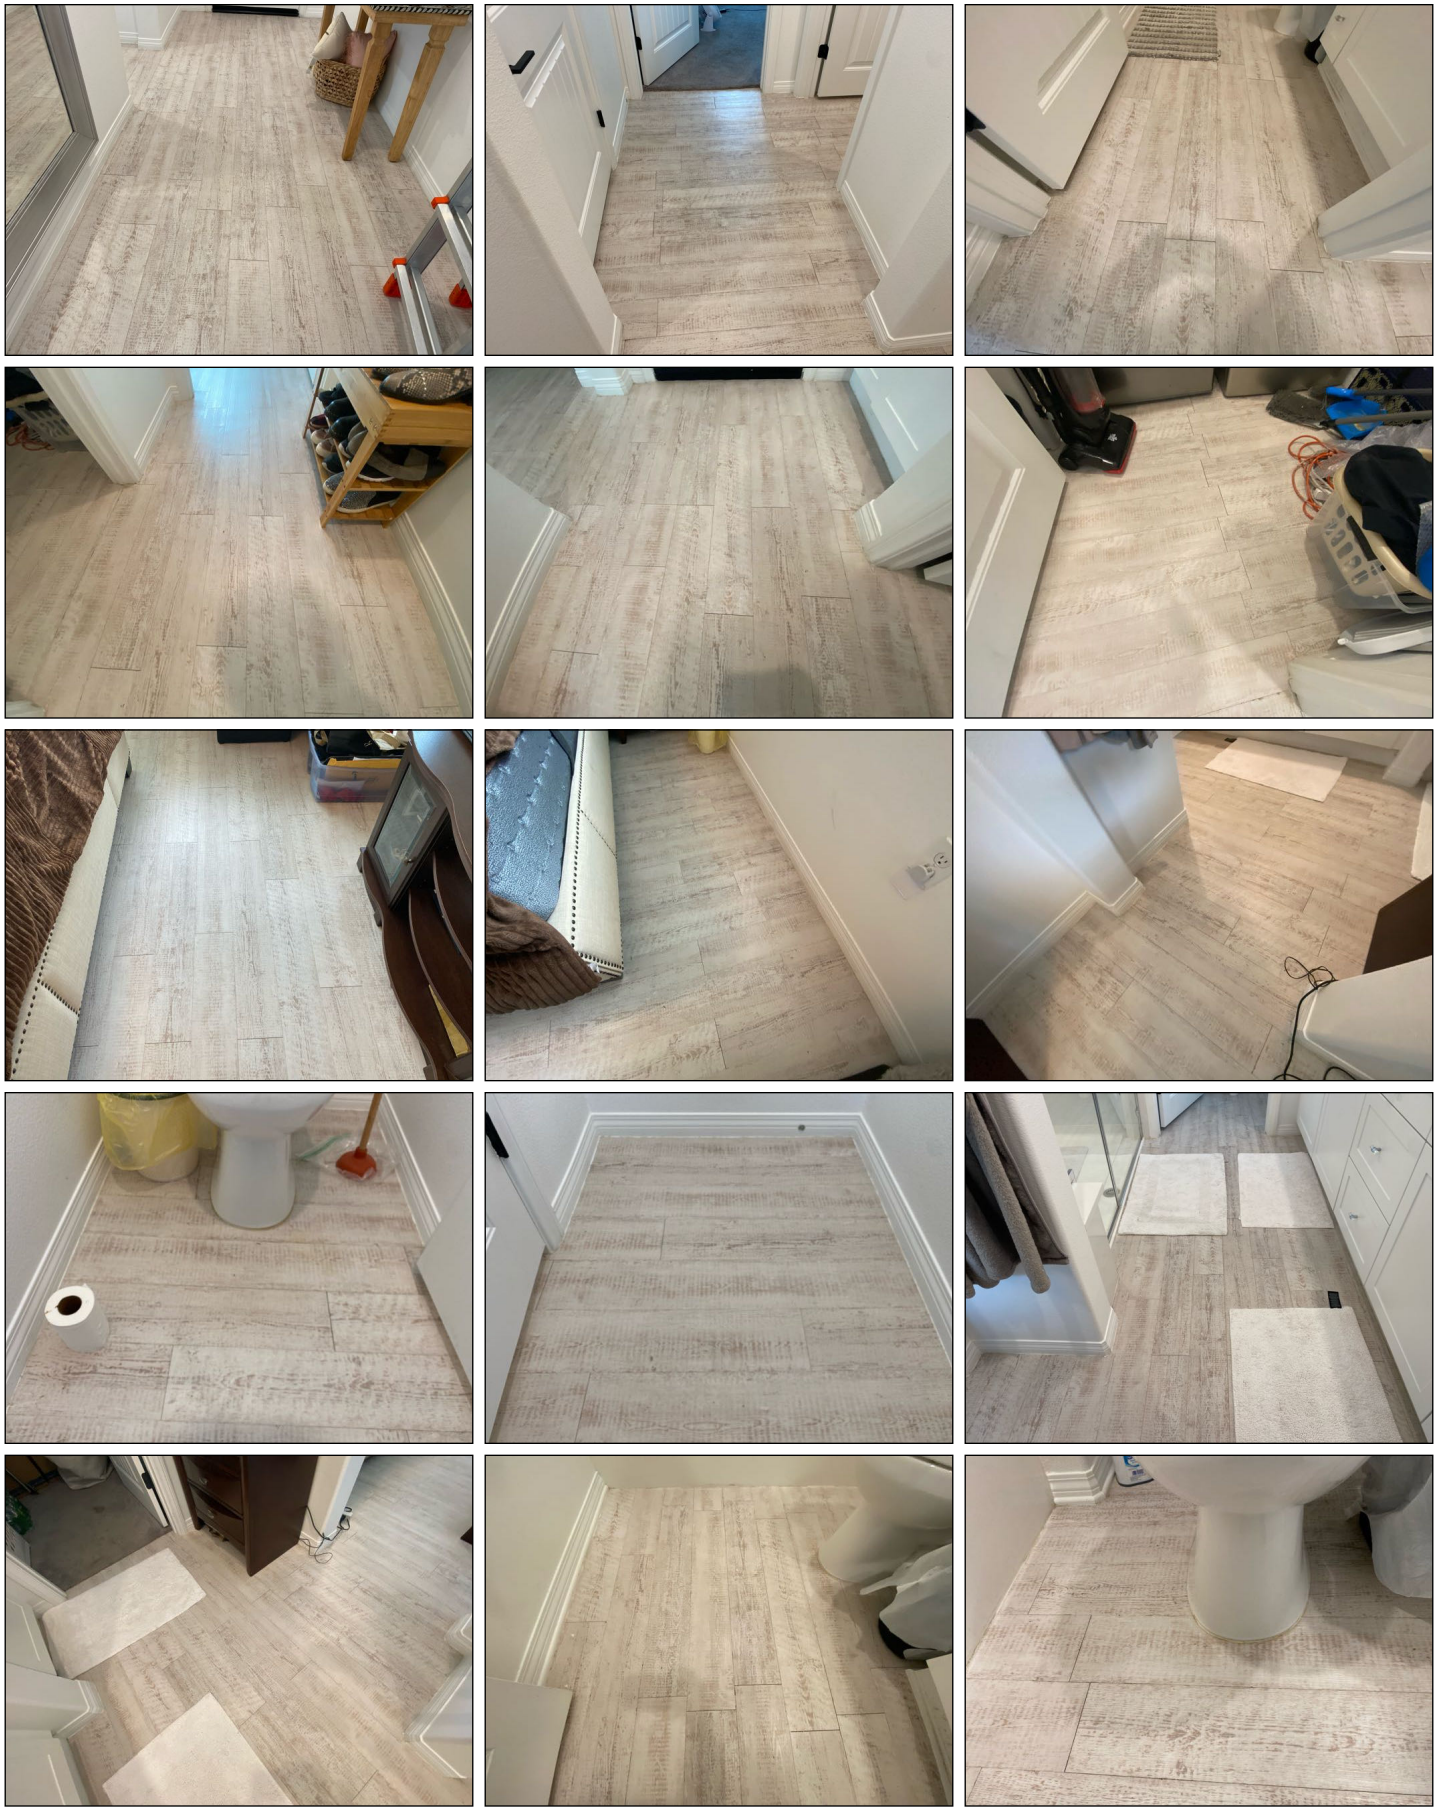
Could not locate remote - unit not tested

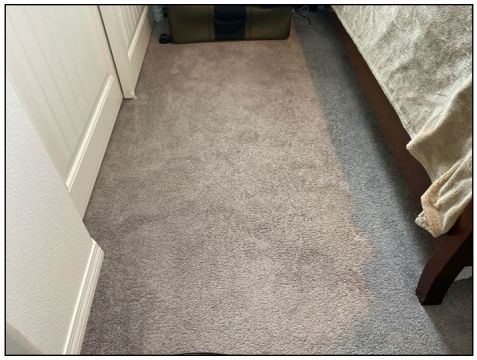
Open seams/gaps in areas - recommend sealing any cracks or voids in flooring

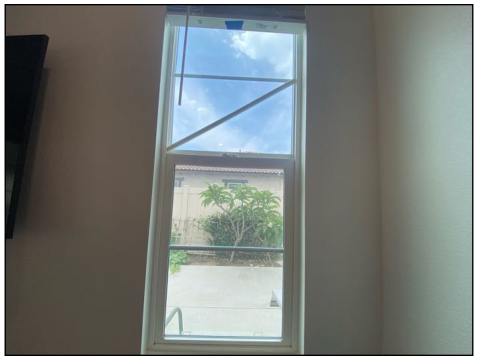
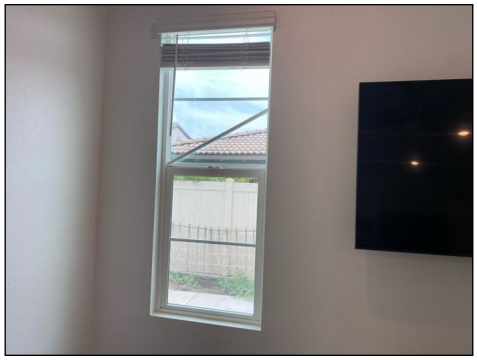
6. Window Conditions

Observations:
- Visible/accessible windows have worn frames/hardware/sills/tracks - typical for age
- Recommend general window maintenance/lubrication and weather tight service
- Recommend window contractor for further evaluation
- Loose sash springs or cables - needs to be serviced
- Recommend general window maintenance/lubrication and weather tight service

Broken sash cables or springs- unsafe - needs to be serviced living room

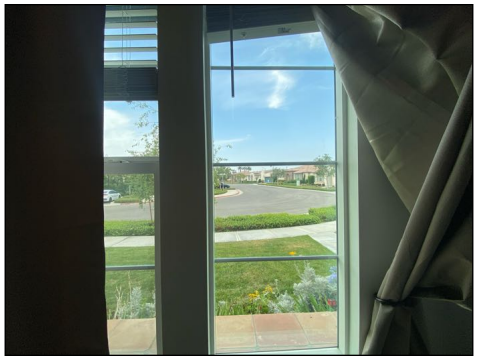
Broken sash cables or springs- unsafe - needs to be serviced living room

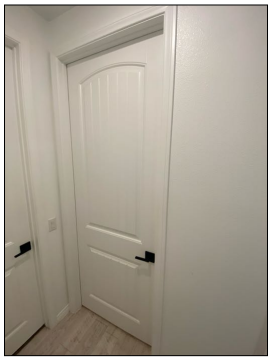
Sticks at jamb - needs to be serviced front door

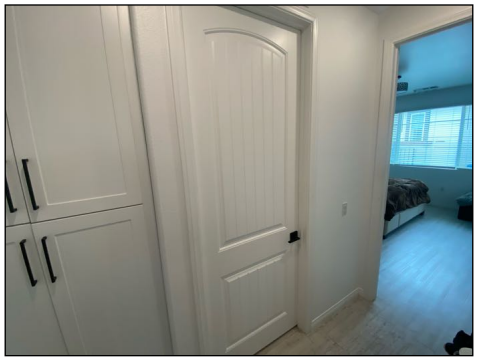
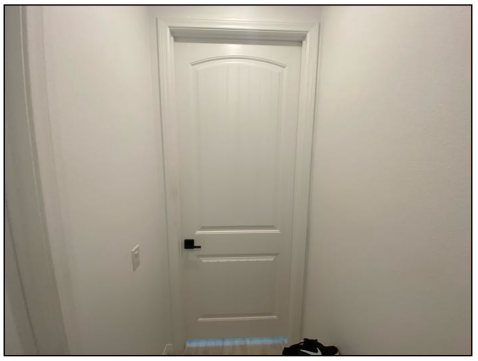
Sticks at jamb - needs to be serviced front door

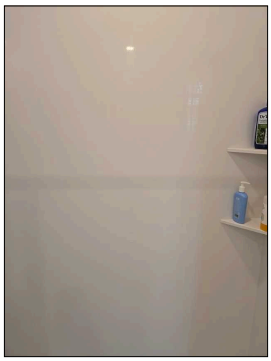
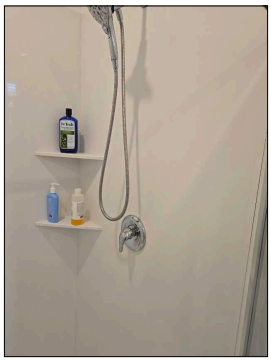
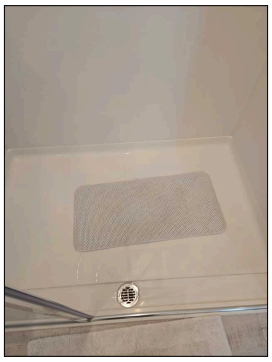
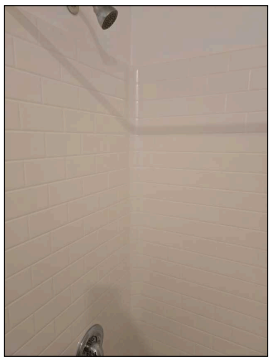
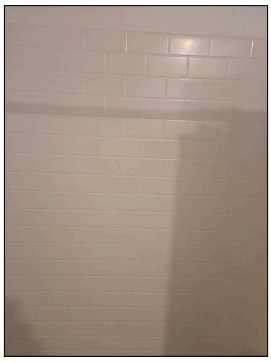
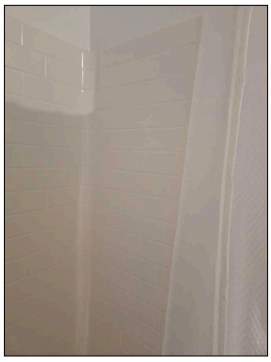
8. Shower Walls

Observations:
• Fiberglass surround present
• Shower walls have normal wear for age at the time of the inspection - no major visible defects - recommend routine grout and sealer maintenance

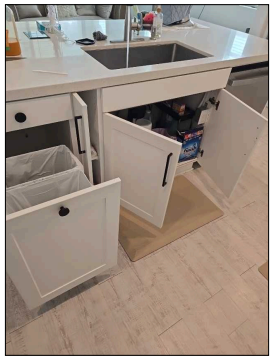
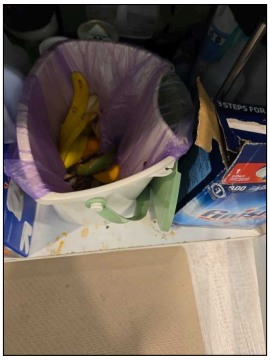
2. Cabinets

Observations:
- Some interior cabinet areas not visible for inspection due to personal storage
- Normal wear for age of material - no major visible defects
- Stained areas below sink - dry at time of inspection

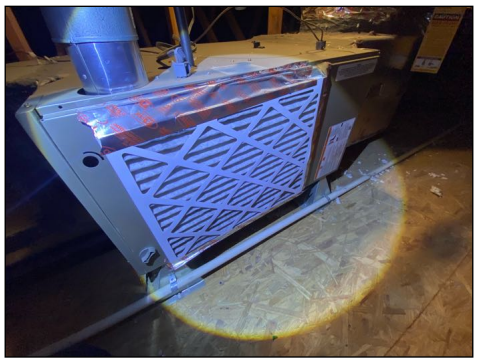
Observations:
• Operated at time of inspection
• Normal wear for age with no major visible defects
• Dirty/dusty unit - recommend cleaning

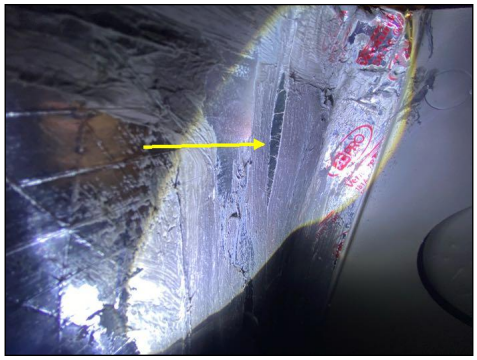
Air leak at connection to furnace - needs to be taped

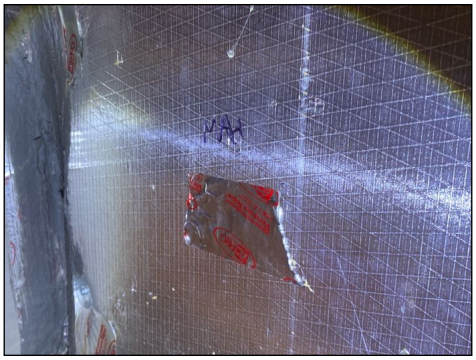
Observations:
- The visible areas of the vent have normal wear at the inspection - no major visible defects
- Recommend securing and sealing all vent connections
- Missing screws at vent connections - needs to be serviced, three screws are recommended at all vent connections

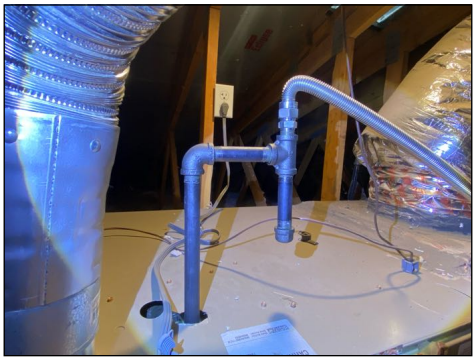
5. Gas Supply Valves and Pipes

Observations:
- Normal wear at time of inspection - no major visible defects
- Sediment trap present

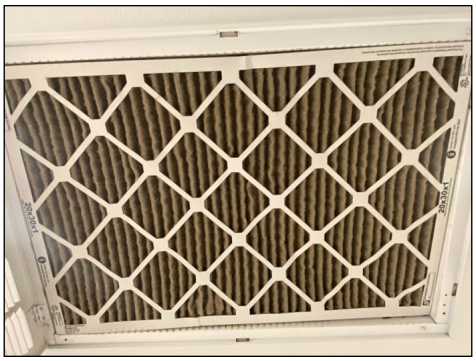
8. Filters

Location: Located in a filter grill in an interior area ceiling • Ultraviolet light air/coil treatment system(s) present - not inspected
Observations:
• Filter is worn/dirty and will likely need changing soon
• A seasonal HVAC service contract is recommended to ensure that all filters are changed/cleaned regularly or as needed

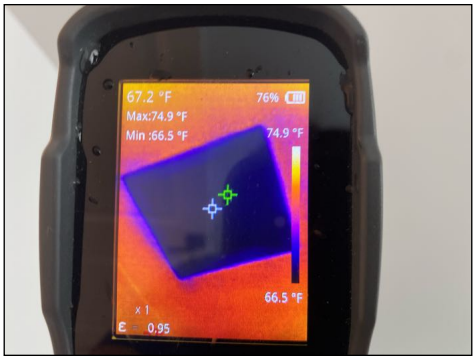
9. Registers

Observations:
• Heater Temperature at Registers: 110 degrees
• A/C Temperature at Registers:60 degrees
• Temperature at Air Return:70 degrees
• Representative number tested and functional day of the inspection

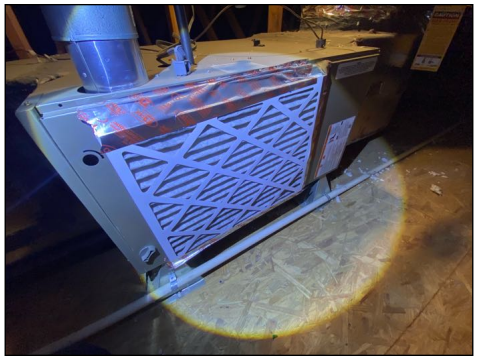
10. Combustion Air

Observations:
• Combustion air appears to be restricted - needs to be serviced

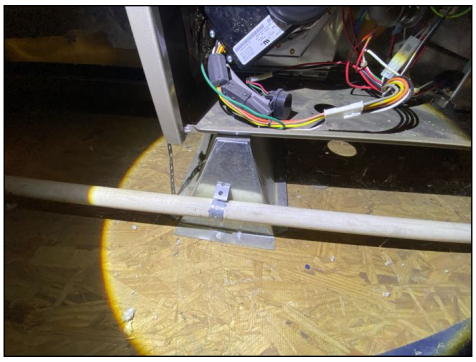
11. Platforms/Bases

Observations:
• Visible areas have normal wear at time of inspection - no major visible defects - recommend seasonal servicing and maintenance to ensure sealing holes and gaps in the heater base
• Horizontal heater in the attic, we recommend adding a heat shield below this unit to prevent any heat damage to the materials below the unit.

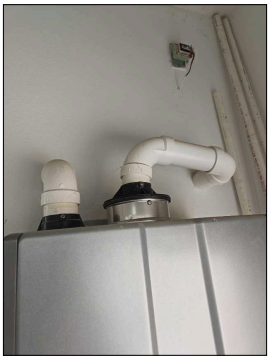
1. Water Heaters Condition

Number of gallons: Tankless demand unit
Location/s: Garage
Observations:
• Operated at the time of the inspection - Gas unit
• Visible areas of unit have normal wear for the age at the time of the inspection with no major visible defects

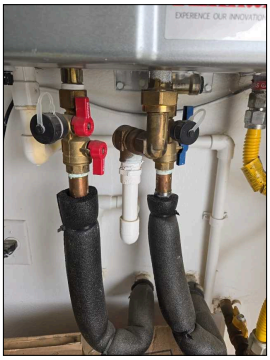
3. Plumbing

Material type: Copper • Stainless steel flex lines • Partially insulated lines - some plumbing lines are not visible • Expansion tank is present (visually inspected only)
Observation:
• Normal wear at time of inspection - no major visible defects or leaks found at the time of the inspection

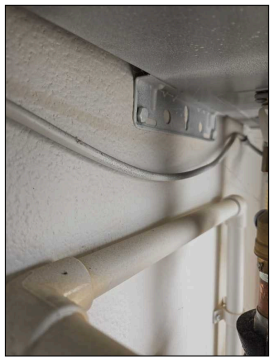
8. Strapping

Obserations:
• Tankless water heater present and appears to be securely mounted to the wall with no major visible defects at the time of the inspection.

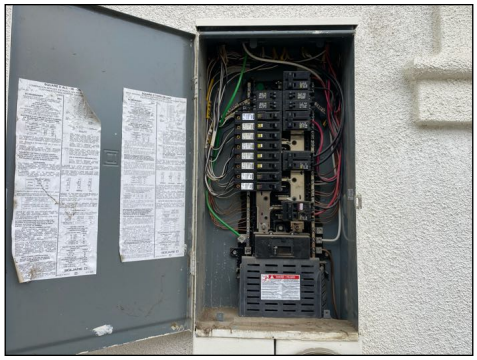
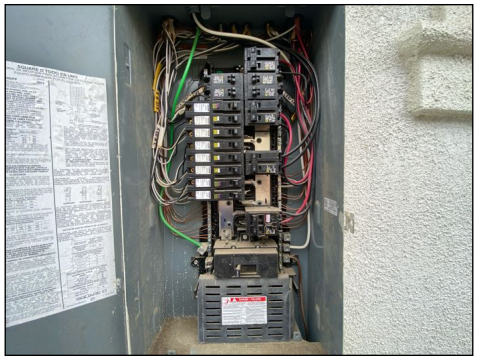
3. Panel Wiring

Observations:
• Wiring type: copper
• Wiring method: non-metallic sheathed cable (romex)
• Grounded panel - main ground/bonding wire observed and appears to be normal for the age of the panel
• Visible wiring has normal wear for age with no major visible defects at the time of the inspection

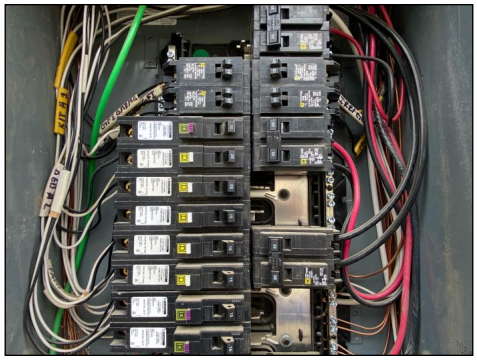
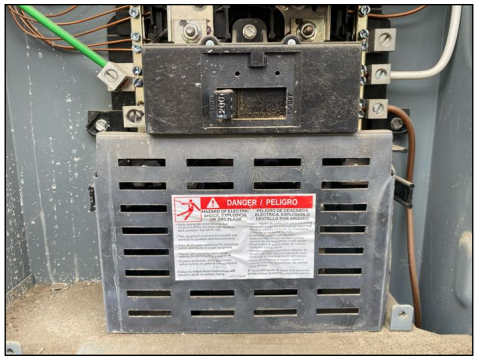
4. Breakers

Observations:
• Labels are present on panel cover - the inspector does not confirm accuracy of labels
• Normal wear for age at time of inspection - no major visible defects

Thermal Image View - Normal temperature readings with no visible signs of overheating at time of inspection

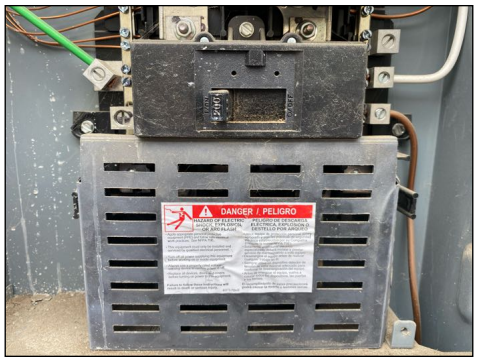
5. Breaker Amp Capacity

Observations:
- Main breaker rating per label: 200 AMPS

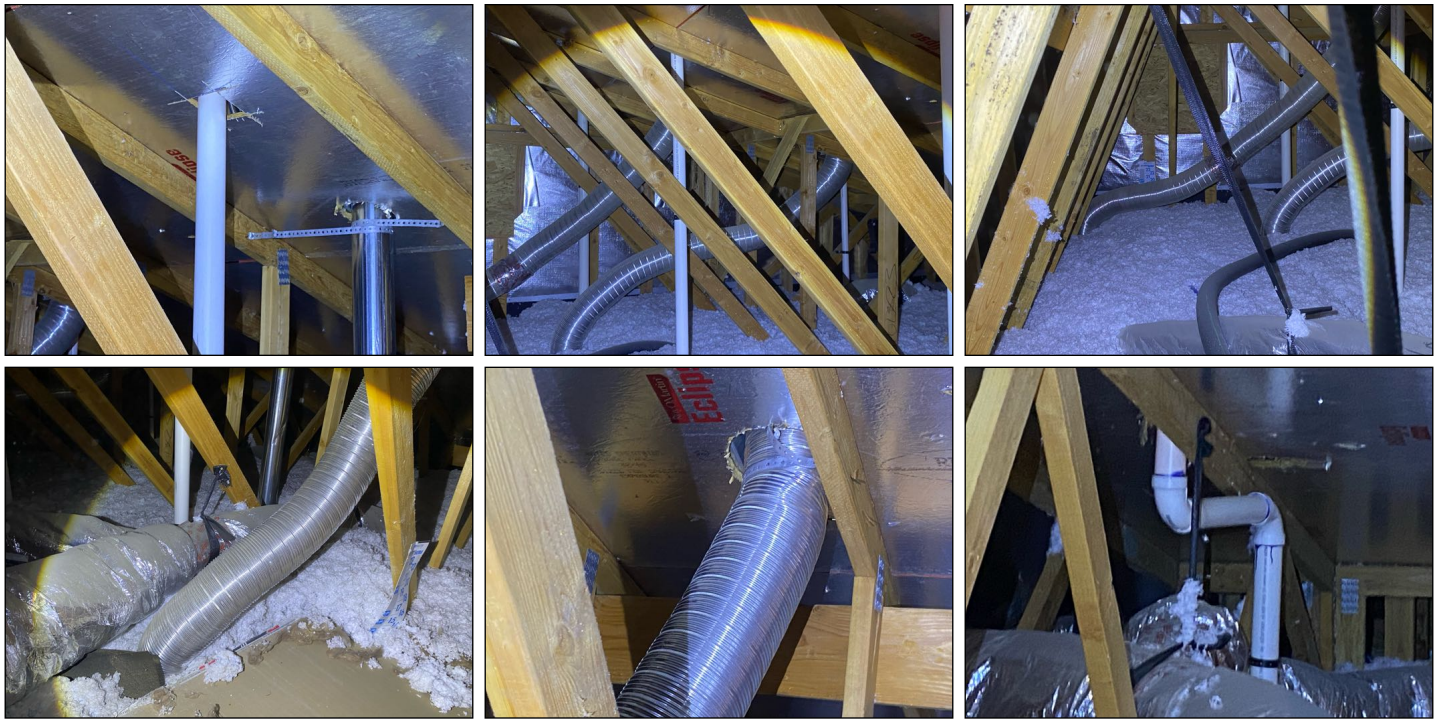
Observations:
• Existing ventilation appeared to be adequate on the day of the inspection

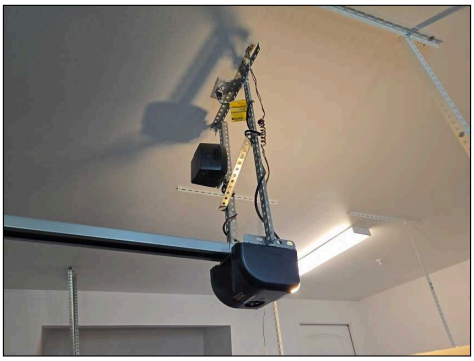
4. Hardware/Springs

Observations:
• ***Garage doors require periodic maintenance and is recommended to ensure that all hardware is properly lubricated and secured***
• Normal wear at time of inspection - no major visible defects

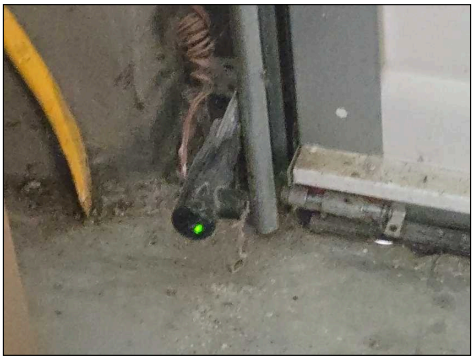
6. Garage Doors Reverse Safety Status

Observations:
• Light beam was tested; the inspector interrupted the beam during closing, the door stopped and reversed back open on the day of the inspection

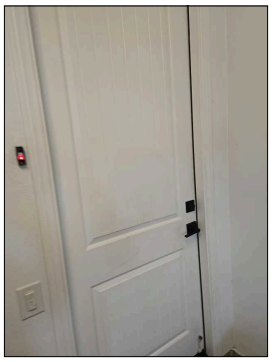
8. Fire Doors

Observations:
- Operated at the time of inspection
- Normal wear at time of inspection - no major visible defects

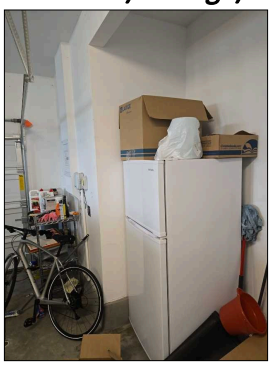
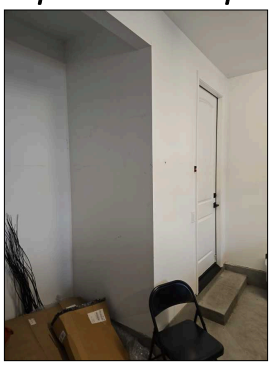
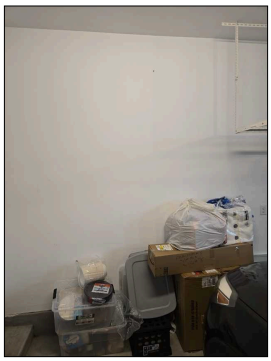
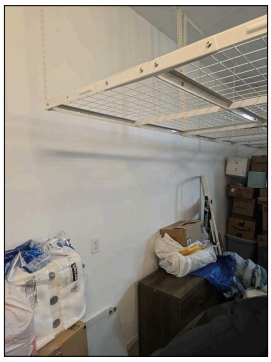
9. Firewalls

Observations:
- Normal wear at the time of inspection - no major visible defects
- Small cracks/holes/chipped/dirty areas/cosmetic blemishes observed - typical for age of structure
- ***Personal items/storage/etc. are present and prevent a complete inspection of firewall areas***

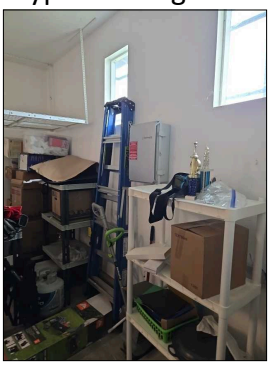
11. Walls

Observations:
- ***Personal items/storage/etc. are present and prevent a complete inspection of wall areas***
- Normal wear at the time of the inspection - no major visible defects
- Small cracks/holes/chipped/dirty areas/cosmetic blemishes observed - typical for age of structure

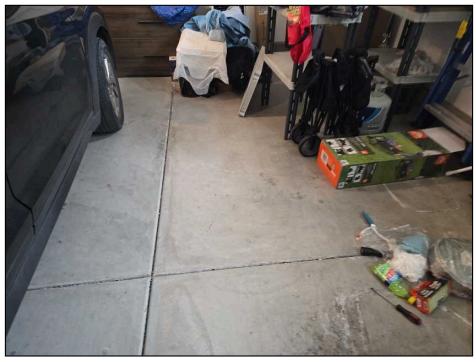
12. Anchor Bolts

Observations:
- Not visible but assumed to exist due to estimated date of construction (bolting requirements began after 1935 in most jurisdictions)

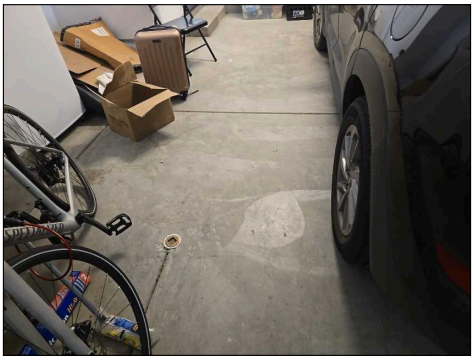
Small cracks/chipped areas - typical for the age of the materials

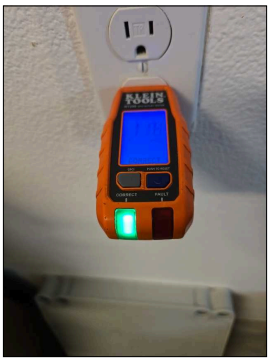
15. Electrical

Observations:
- Outlets/switches had normal wear for age - no major visible defects
- Some bulbs defective/missing/light(s) did not function - check bulbs/consult electrician to further evaluate

Some bulbs defective/missing/light(s) did not function - check bulbs/consult electrician to further evaluate

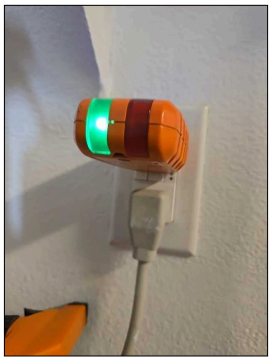
16. GFCIs

Observations:
- Tested and operational at time of inspection via normal control

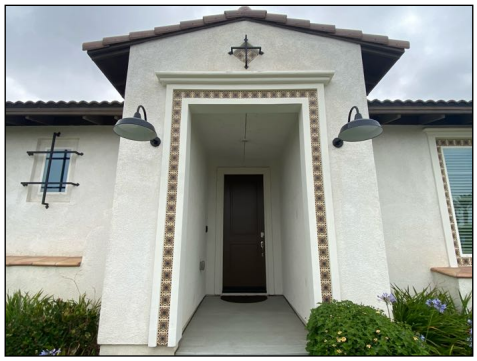
20. Electrical Chase/Soffit

Observations:
• No soffit or chase present - N/A

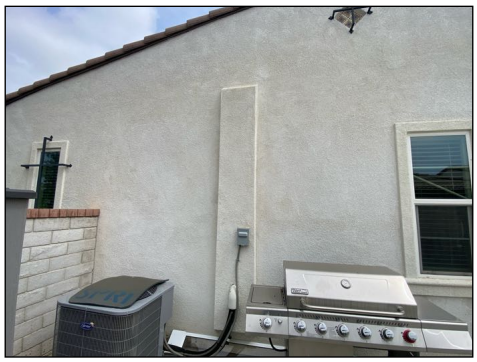
Blistered due to irrigation over spray - recommend adjusting sprinkler heads away from structure areas

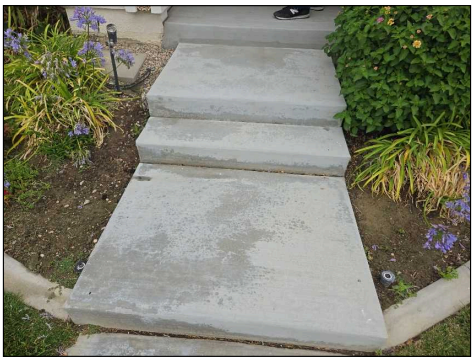
2. Exterior Foundation Perimeter

Observations:
• Vegetation growing against structure prevents visibility or access to some areas of foundation perimeter for inspection
• Normal wear on the day of the inspection where visible - no major defects visible

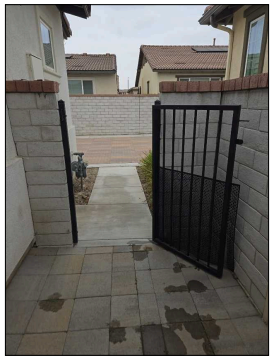
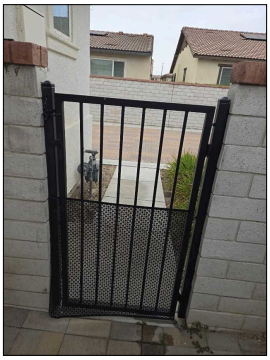
11. Fencing and Walls

Constructed of: Block • Vinyl
Observations:
• Visible fencing/wall areas had normal wear on the day of the inspection - no major visible defects
• Visible fencing/wall areas are worn and weathered - typical for the age of the materials
